CASE STUDY

A473 BRIDGEND INNER BYPASS BRIDGE, SOUTH WALES - BEARING REMOVAL & INSTALLATION

Job Brief

Supplied: Removal of 65 no rocker bearings.
Design, manufacture, supply and
installation of 65 no mechanical pot
bearings.

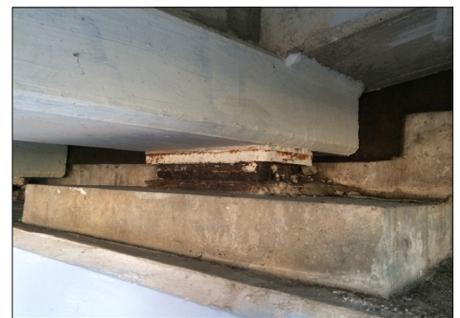
The steel bearings supporting the bridge deck were excessively corroded to the extent that some had 'seized', and were consequently deemed as being inadequate to accommodate the expansion and rotational forces which they were originally designed for. To alleviate this increased stress transferred into the bridge deck and supports, these bearings had to be replaced.

Old rocker bearing corroded and no longer functional

Ekspan were contracted by Dyer & Butler to replace the existing 65 no Glacier steel rocker bearings with Ekspan BS5400 mechanical pot bearings on the West abutment, at the East and West piers of Bridgend inner bypass bridge. Due to the complexity of the structure's design and the existing bearing dimensions, the new installed bearings were designed and manufactured as bespoke pot bearings.

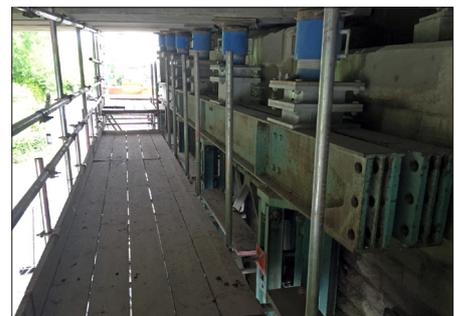
Super props and jacks temporarily supporting the bridge deck

Works on this project included marking-up and prepping site for installation of temporary works / bridge propping; hydro demolition of bearing / bridge beams, piers and abutment; bearing removal; construction and installation of steelwork beams as plate/stool arrangements for the new pot bearings to be fixed to; bearing installation; concrete repairs works for encapsulation of steelworks and bearing top plates and base plate sockets; concrete repair to piers and abutments and final grouting of the new installed bearings.

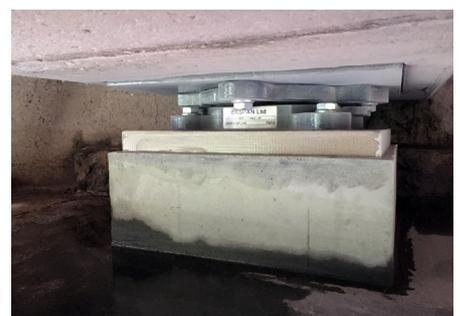
New installed mechanical pot bearing fixed to the bridge beam and bearing shelf
