WEST SOLE PLATFORM, WA-WAP LINK BRIDGE - BRIDGE JACKING & BEARING REPLACEMENT

Supplied: **Bearing supply, bridge jacking and bearing replacement works**

Client: Perenco (UK) Ltd
Main Contractor: Ekspan
Start Date: 2015
Completion Date: 2015

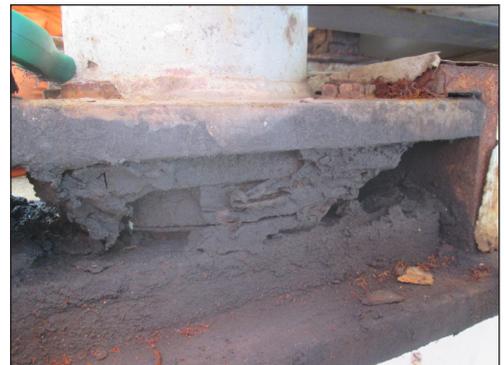
The existing bearings all appeared to be original PSC inverted mechanical pot bearings that had been supplied circa 1983. The findings revealed these bearings had reached the end of their design life and needed to be replaced. Excessive corrosion and debris to bearing fixings, uplift brackets and adjacent steelwork had caused stress on the bearings, which subsequently resulted in skew, between bridge and jacket structures inhibiting movement.

Existing bearing prior to removal shows excessive corrosion

Ekspan were appointed by Perenco to replace these mechanical bearings.

The inspection had confirmed a number of dimensional inaccuracies associated with the original bearings. The main dimensional differences related to the fixing hole centres and the overall base plate lengths for the WAP end bearings. Ekspan manufactured 4 no bespoke mechanical pot bearings (1 fixed and 3 guide) to suit the existing dimensions and load criteria. The sequential methodology for bearing replacement and careful monitoring throughout enabled successful completion of works while also maintaining restraint between the bridge and the platform.

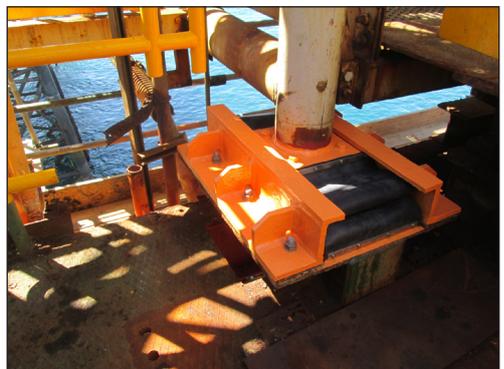
Bearing replaced complete with protective cover

To prolong the bearing life stainless steel slide plates were fully welded to the base plates, to prevent de-lamination. Protective rubber skirts were installed to protect the sliding surfaces and reduce the effects of debris ingress.
